Catholic Churches in the Visayas and the Earthquake of 15 October 2013

Philippine Studies: Historical and Ethnographic Viewpoints
vol. 64 nos. 3–4 (2016): 625–40

Our Lady of Light Church, Loon, Bohol

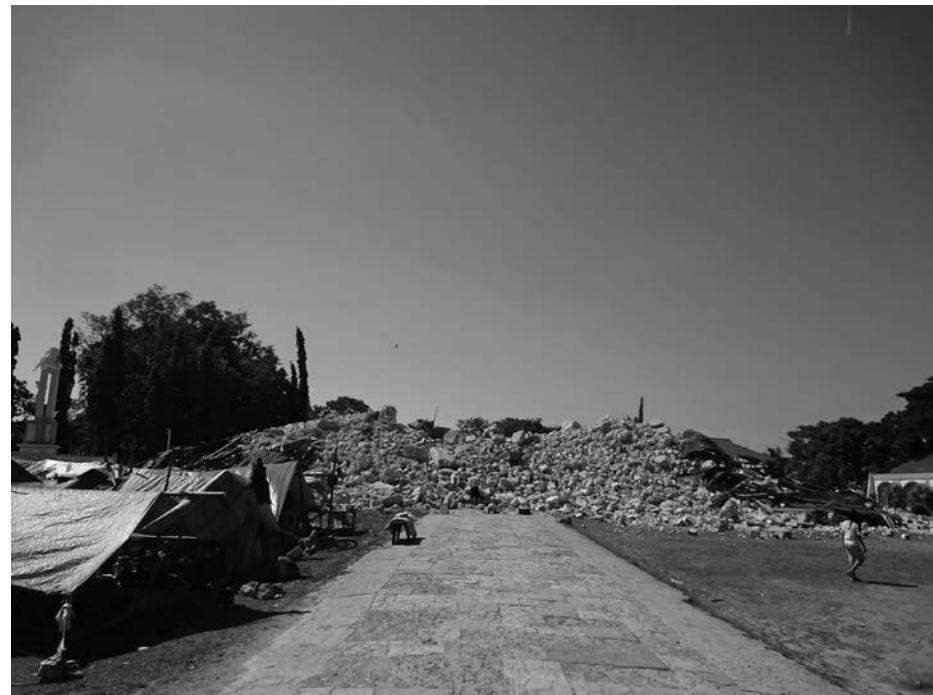
Ruins of Our Lady of Light Church, 18 Oct. 2013; photo courtesy of the NHCP

Cultural properties are most vulnerable during earthquakes. In the history of architecture and its technological achievements, old construction methodologies formed part of the evolution of design and styles. Builders developed construction technologies through time to correct a structure and enhance its strength. Seismic considerations established the strength of a structure. Building technologies were constantly changing to create earthquake-responsive buildings. The Our Lady of Light Church in Loon, Bohol, built in 1755, completely collapsed after the 7.2 magnitude earthquake that hit the Central Visayas on 15 October 2013. The stone church, declared a National Historical Landmark and National Cultural Treasure, was the largest and most symmetrical religious edifice in Bohol.

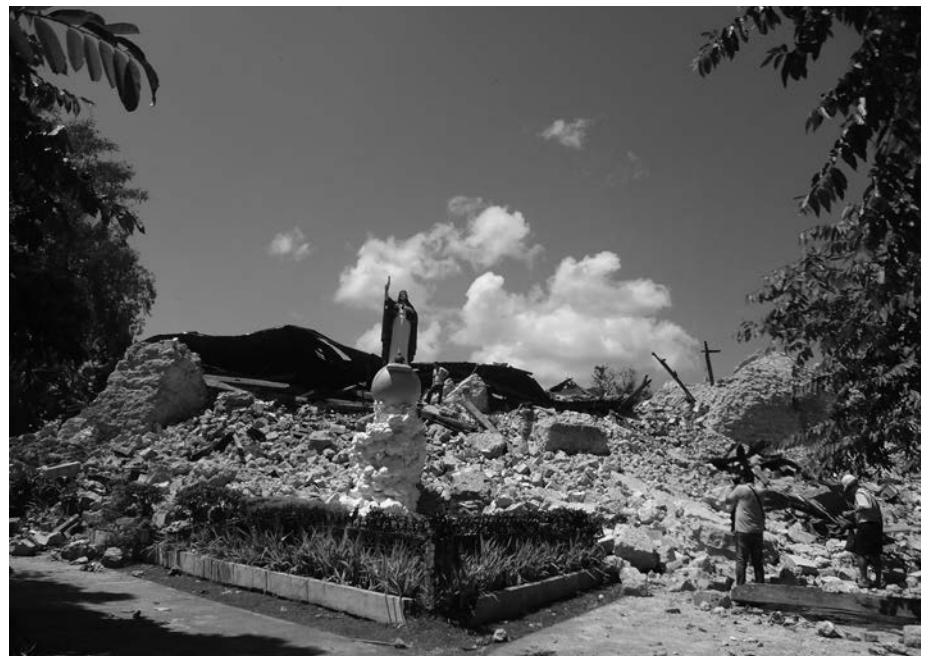
Ruins of the Santa Cruz Church, 18 Oct. 2013; photo courtesy of the NHCP

Churches in the Visayas, particularly in Bohol and Cebu, were made of corals. Rene Javellana (1991) described the corals, or *piedra de Visayas*, as handsome building materials because of their unusual texture. It could be as hard as marble or as soft as limestone. Corals were quarried during low tide and hewn either on the shore or near the building site. The structural capabilities of corals, which are equivalent to 22 megapascals or 3,191 psi, are still appropriate by contemporary standards. However, given the age and degree of maintenance work done in the church, corals become weak. Months before the earthquake, the Santa Cruz Church in the town of Maribojoc, built from 1852 to 1872, had been up for repair work since the coral stones at the bell tower detached from its rubble core. Unfortunately, the entire structure collapsed during the earthquake.

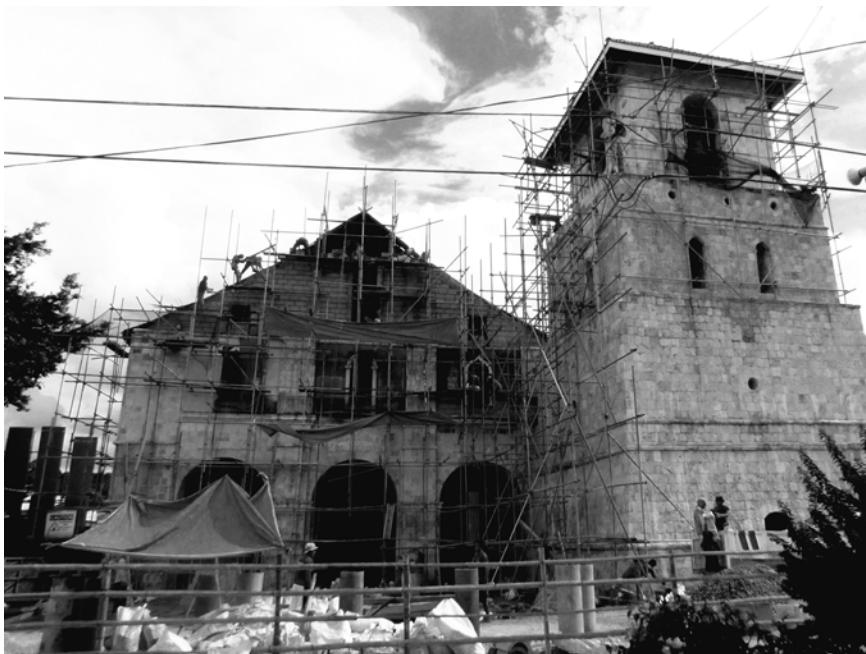
On-going restoration work on Immaculate Conception Church, 9 Sept. 2016; photo courtesy of the NHCP

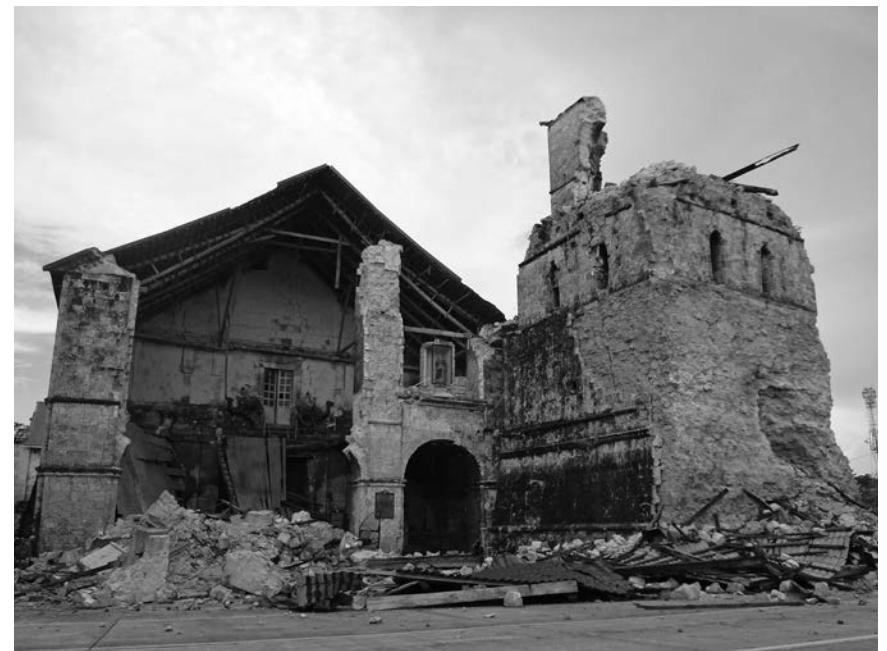
Ruins of the Immaculate Conception Church, 17 Oct. 2013; photo courtesy of the NHCP

The concept of separate bell towers, use of thick masonry walls, and addition of massive buttresses were among the technological breakthroughs in the construction of religious edifices in the Philippines in the eighteenth and nineteenth centuries. Stone churches were constructed quakeproof, with thickened walls and propped with outsized buttresses by the turn of the seventeenth century. Walls were maintained through lime plasterwork of masonry walls. Times have changed, and modern ways of seismic treatments in building technology have been developed. The Immaculate Conception Church in Baclayon, built in the late 1700s, has a wooden truss system that has been maintained and preserved. Experts believe these structural supports have helped save the main church, owing to its tensile properties, from the wrath of the earthquake. However, the portico façade, added in 1875 made of combined corals and concrete, collapsed.

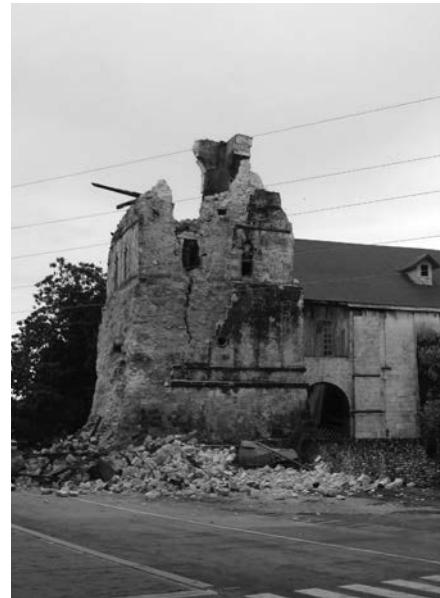
Bell tower in ruins, 18 Oct. 2013;
photo courtesy of the NHCP

The bell tower of Baclayon was originally detached from the church building. Erected in 1777, the tower served as a military structure or a watchtower to protect the growing parish. The portico façade, added in 1875, connected the tower to the building. Hence, structural experts inferred that the connection between the two structures may have affected their seismic behavior during the earthquake. Claudia Cancino (2011), in her damage assessment report of historic earthen buildings after the 2007 earthquake in Pisco, Peru, recommended the need to develop less invasive alternative retrofitting techniques by adapting traditional and historical methods and materials in order to increase safety in existing earthen buildings. Simple interventions to connect wall to roof may have minimized the damage to the Cathedral of Ica, Peru.

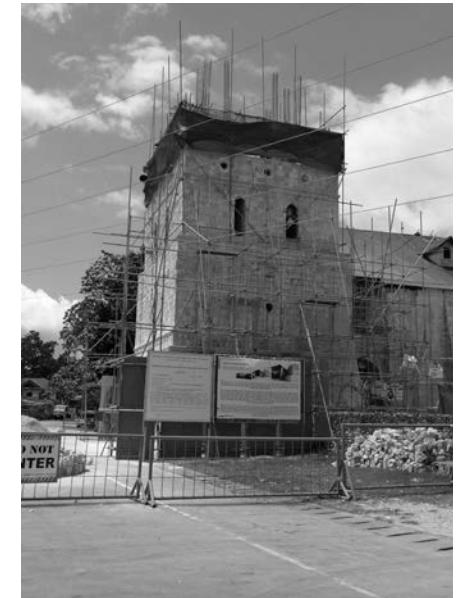
Restoration of the bell tower, 29 Feb.
2016; photo courtesy of the NHCP

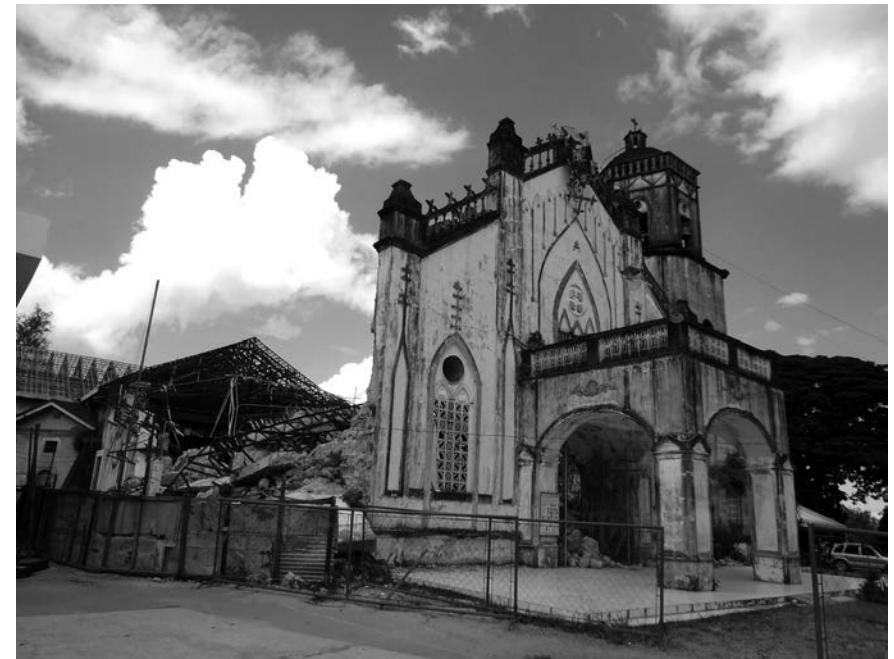
St. John the Apostle Church, 15 May 2014; photo courtesy of the NHCP

The St. John the Apostle Church in Inabanga, Bohol, has evolved from a stone masonry structure to a semiconcrete building through time. The Gothic-inspired façade was spared by the local earthquake, but the masonry walls collapsed. The Nara Document on Authenticity drafted in 1994 (UNESCO World Heritage Centre 1994) states that authenticity does not require a significant place to be frozen as it is. The outstanding values of a place may be sustained dynamically so long as its stories remain credible and truthful. The community of Inabanga wanted to reconstruct the church and add more windows at the side walls. The parish is committed to preserve the remnants of the past and also improve the church's appearance.

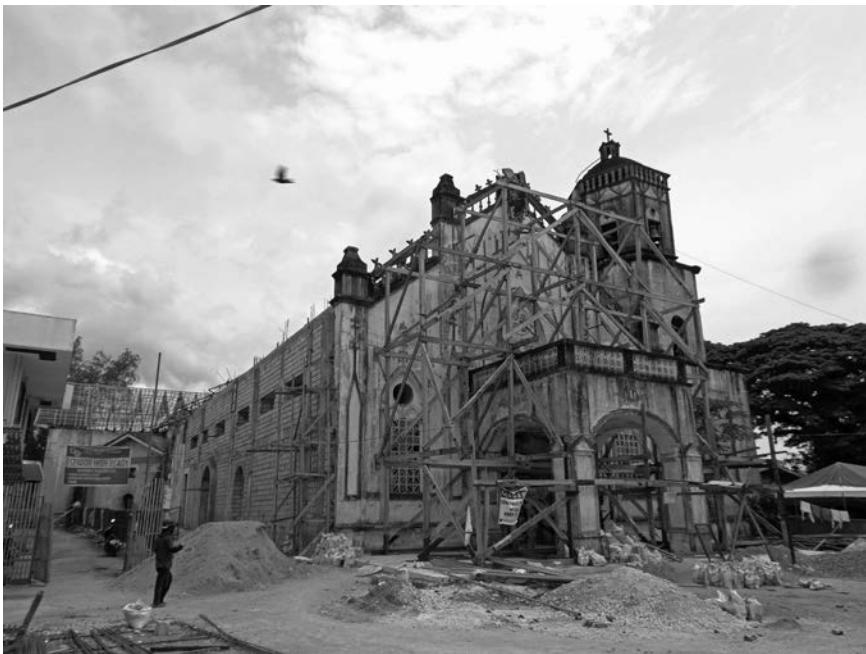
St. John the Apostle Church undergoing restoration, 29 Feb. 2016; photo courtesy of the NHCP

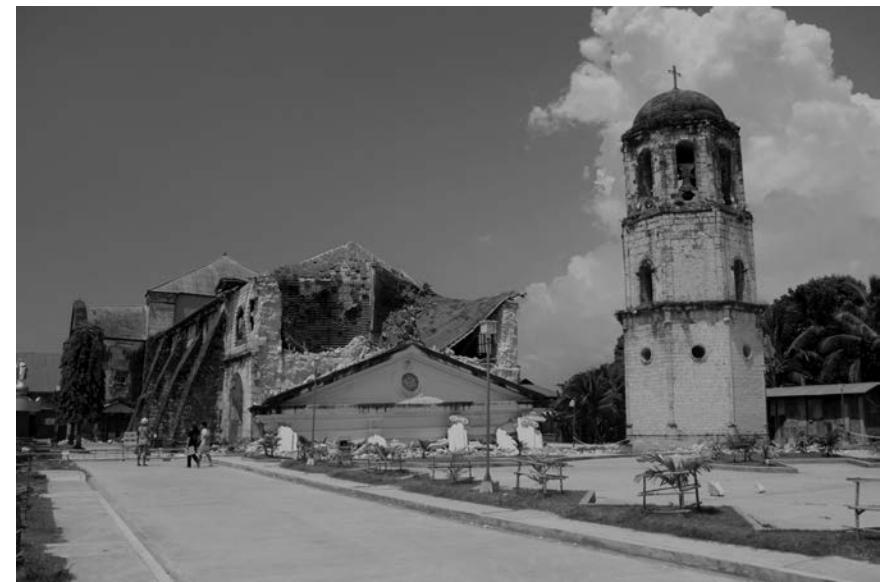
Holy Trinity Church, 18 Oct. 2013; photo courtesy of the NHCP

Attendance at church ceremonies plays a huge impact on the culture of the community. It is imperative to search deeper into the pulse of the community on matters concerning heritage and preservation. Congregations are living entities that should continue regardless of place. The parishioners of Holy Trinity Church in the hilltop town center of Loay, Bohol, have built a makeshift church at the church plaza to address the needs of the parish while the National Historical Commission of the Philippines (NHCP) and the community are rebuilding the damaged house of worship.

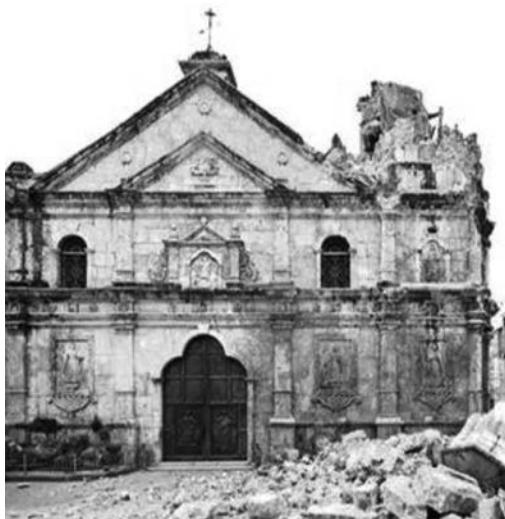
Facade of the Santo Niño de Cebú Basilica with the damaged belfry, 17 Oct. 2013; photo courtesy of the NHCP

The concrete belfry of the Santo Niño de Cebú Basilica fell down as a result of the 2013 earthquake. Experts concluded that the collapse happened owing to the heavy weight of the reinforced concrete structure previously added to the church structure. To restore it, the NHCP used the same old methodology and architectural design. However, lightweight concrete was used to match the strength of the old masonry walls. Coral stones were used as architectural cladding. Thus, mistakes on construction methodologies in the past should never be repeated. Adaptable new technologies enable us to take full advantage of the use of heritage buildings.

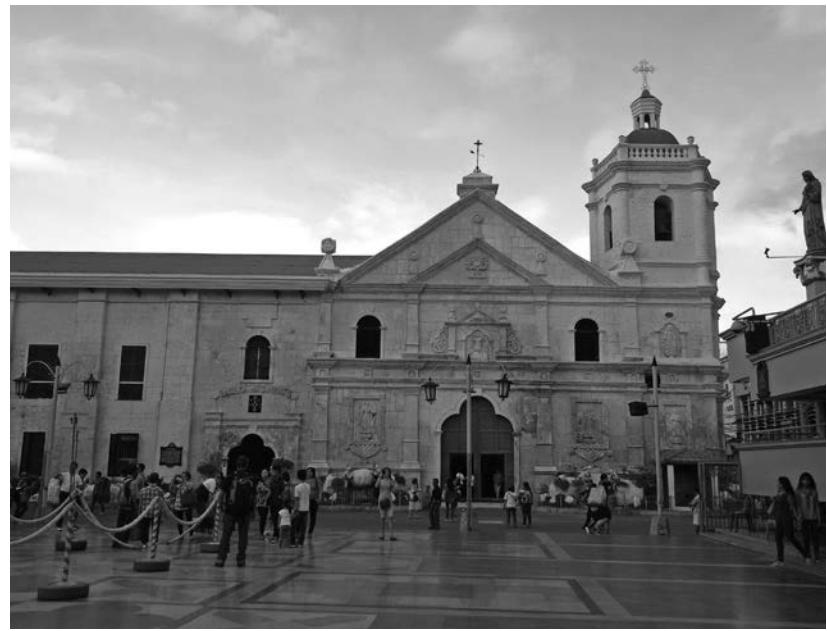
Santo Niño de Cebú Basilica with the restored belfry, 7 June 2016; photo courtesy of the NHCP
