Catholic Churches in the Visayas and the Earthquake of 15 October 2013

Philippine Studies: Historical and Ethnographic Viewpoints
vol. 64 nos. 3–4 (2016): 625–40

Our Lady of Light Church, Loon, Bohol

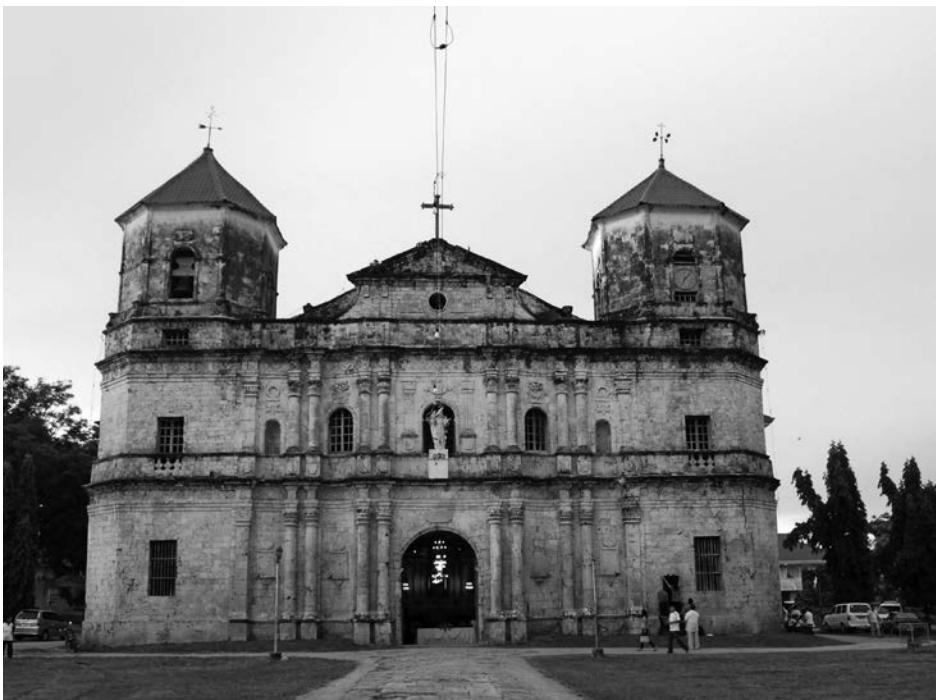
Our Lady of Light Church façade, 12 Dec. 2010; photo courtesy of the NHCP

Cultural properties are most vulnerable during earthquakes. In the history of architecture and its technological achievements, old construction methodologies formed part of the evolution of design and styles. Builders developed construction technologies through time to correct a structure and enhance its strength. Seismic considerations established the strength of a structure. Building technologies were constantly changing to create earthquake-responsive buildings. The Our Lady of Light Church in Loon, Bohol, built in 1755, completely collapsed after the 7.2 magnitude earthquake that hit the Central Visayas on 15 October 2013. The stone church, declared a National Historical Landmark and National Cultural Treasure, was the largest and most symmetrical religious edifice in Bohol.

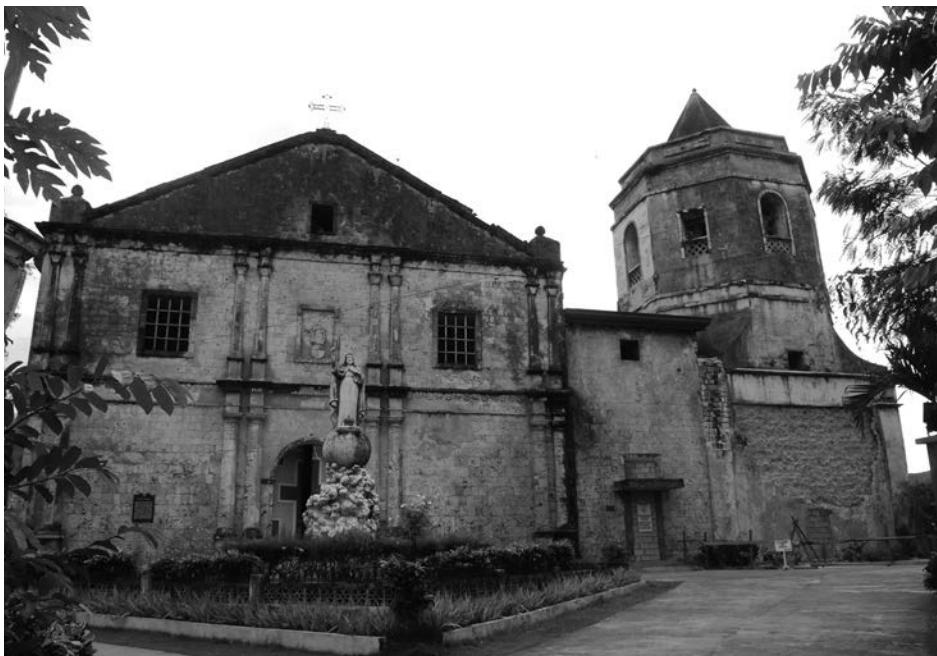
Santa Cruz Church, Maribojoc, Bohol

Santa Cruz Church façade, 13 Oct. 2010; photo courtesy of the NHCP

Churches in the Visayas, particularly in Bohol and Cebu, were made of corals. Rene Javellana (1991) described the corals, or *piedra de Visayas*, as handsome building materials because of their unusual texture. It could be as hard as marble or as soft as limestone. Corals were quarried during low tide and hewn either on the shore or near the building site. The structural capabilities of corals, which are equivalent to 22 megapascals or 3,191 psi, are still appropriate by contemporary standards. However, given the age and degree of maintenance work done in the church, corals become weak. Months before the earthquake, the Santa Cruz Church in the town of Maribojoc, built from 1852 to 1872, had been up for repair work since the coral stones at the bell tower detached from its rubble core. Unfortunately, the entire structure collapsed during the earthquake.

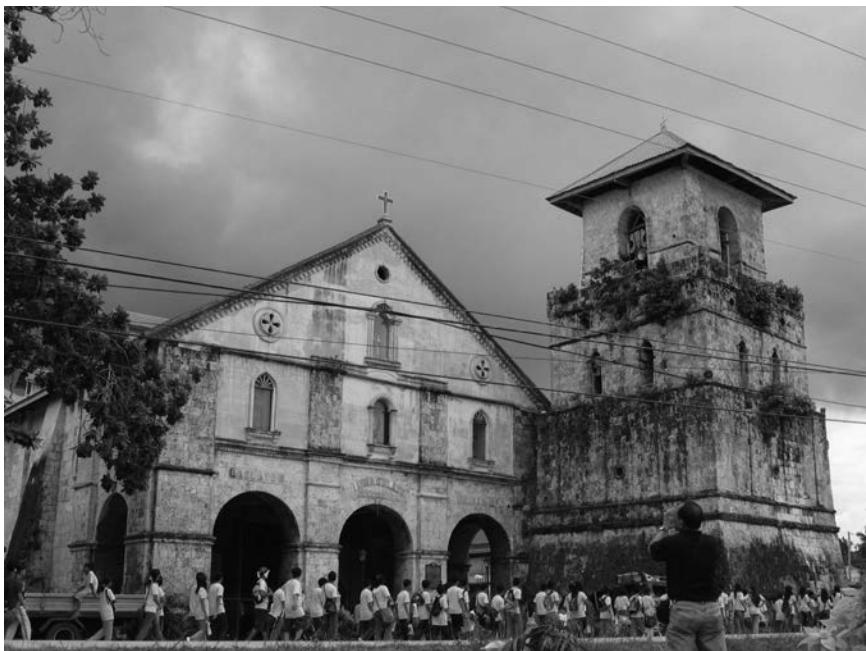
Immaculate Conception Church, Baclayon, Bohol

Immaculate Conception Church and bell tower, 12 Sept. 2007; photo courtesy of the NHCP

The concept of separate bell towers, use of thick masonry walls, and addition of massive buttresses were among the technological breakthroughs in the construction of religious edifices in the Philippines in the eighteenth and nineteenth centuries. Stone churches were constructed quakeproof, with thickened walls and propped with outsized buttresses by the turn of the seventeenth century. Walls were maintained through lime plasterwork of masonry walls. Times have changed, and modern ways of seismic treatments in building technology have been developed. The Immaculate Conception Church in Baclayon, built in the late 1700s, has a wooden truss system that has been maintained and preserved. Experts believe these structural supports have helped save the main church, owing to its tensile properties, from the wrath of the earthquake. However, the portico façade, added in 1875 made of combined corals and concrete, collapsed.

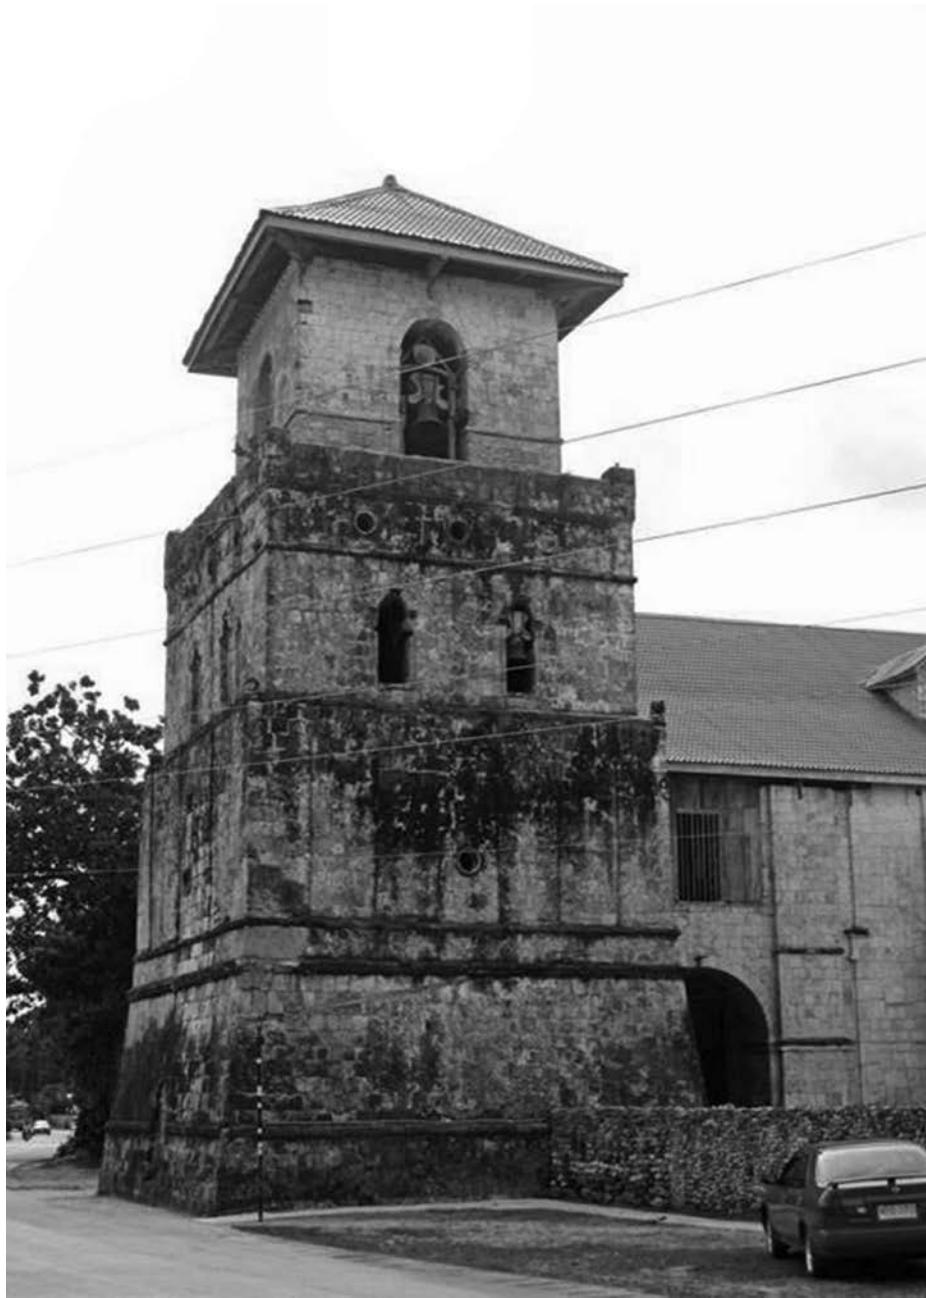
Bell Tower, Immaculate Conception Church, Baclayon, Bohol

Immaculate Concepcion Church bell tower, 12 Sept. 2007; photo courtesy of the NHCP

The bell tower of Baclayon was originally detached from the church building. Erected in 1777, the tower served as a military structure or a watchtower to protect the growing parish. The portico façade, added in 1875, connected the tower to the building. Hence, structural experts inferred that the connection between the two structures may have affected their seismic behavior during the earthquake. Claudia Cancino (2011), in her damage assessment report of historic earthen buildings after the 2007 earthquake in Pisco, Peru, recommended the need to develop less invasive alternative retrofitting techniques by adapting traditional and historical methods and materials in order to increase safety in existing earthen buildings. Simple interventions to connect wall to roof may have minimized the damage to the Cathedral of Ica, Peru.

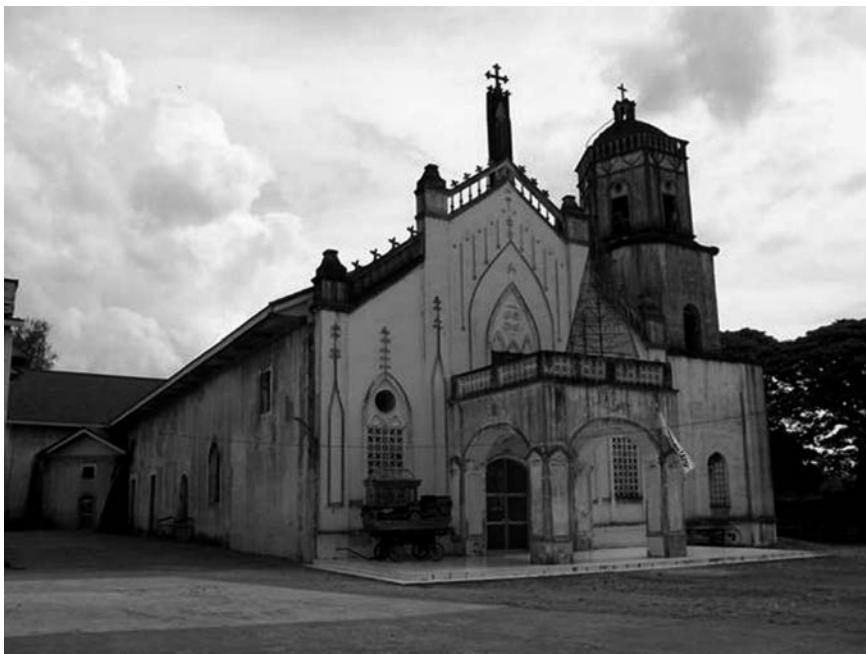
St. John the Apostle Church, Inabanga, Bohol

St. John the Apostle Church, 7 Sept. 2007; photo courtesy of the NHCP

The St. John the Apostle Church in Inabanga, Bohol, has evolved from a stone masonry structure to a semiconcrete building through time. The Gothic-inspired façade was spared by the local earthquake, but the masonry walls collapsed. The Nara Document on Authenticity drafted in 1994 (UNESCO World Heritage Centre 1994) states that authenticity does not require a significant place to be frozen as it is. The outstanding values of a place may be sustained dynamically so long as its stories remain credible and truthful. The community of Inabanga wanted to reconstruct the church and add more windows at the side walls. The parish is committed to preserve the remnants of the past and also improve the church's appearance.

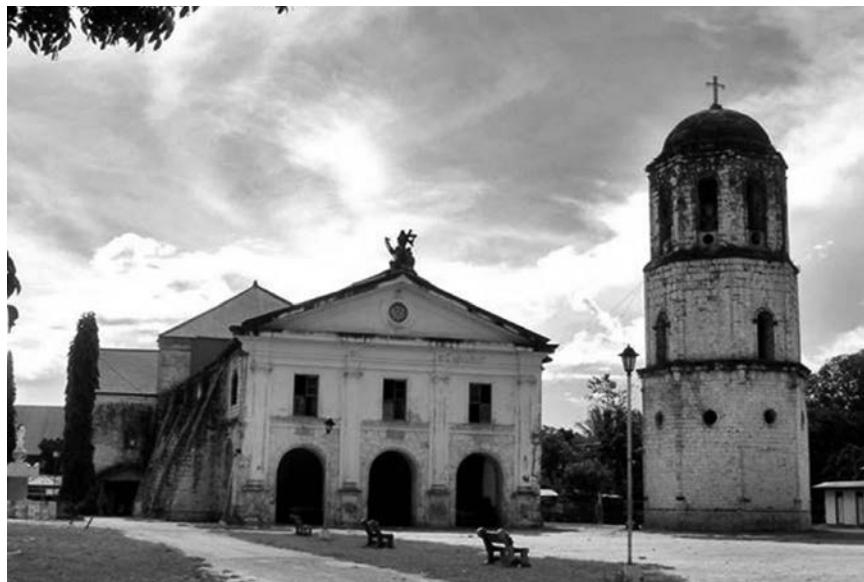
Holy Trinity Church, Loay, Bohol

Holy Trinity Church, 14 Aug. 2008; photo courtesy of the NHCP

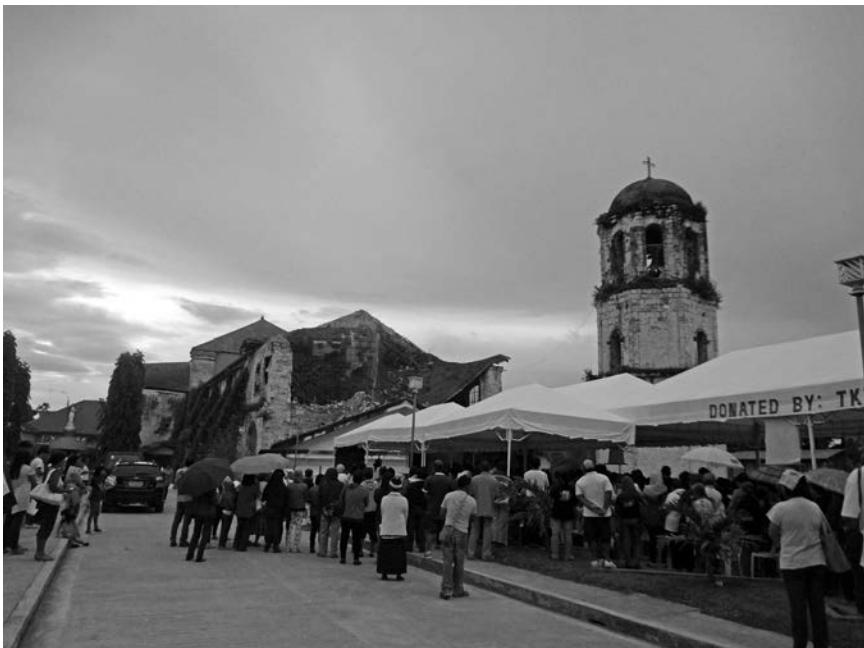
Makeshift church, 12 Apr. 2014; photo courtesy of the NHCP

Attendance at church ceremonies plays a huge impact on the culture of the community. It is imperative to search deeper into the pulse of the community on matters concerning heritage and preservation. Congregations are living entities that should continue regardless of place. The parishioners of Holy Trinity Church in the hilltop town center of Loay, Bohol, have built a makeshift church at the church plaza to address the needs of the parish while the National Historical Commission of the Philippines (NHCP) and the community are rebuilding the damaged house of worship.

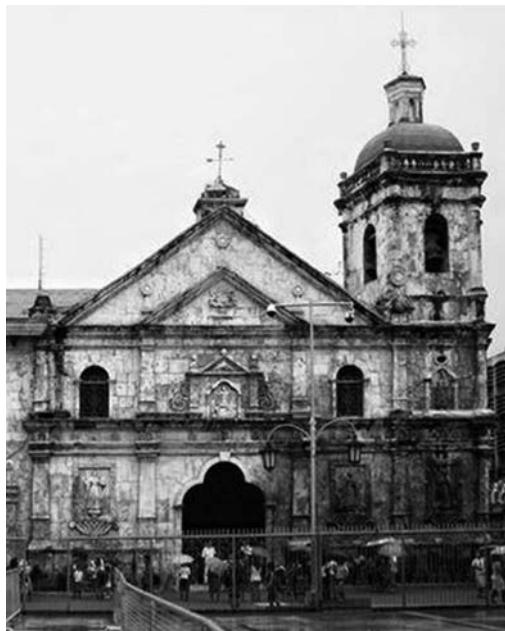
Santo Niño de Cebú Basilica before the 2013 earthquake; photo courtesy of the NHCP
